CCA Treated Wood

The End of the Line

MSW Management

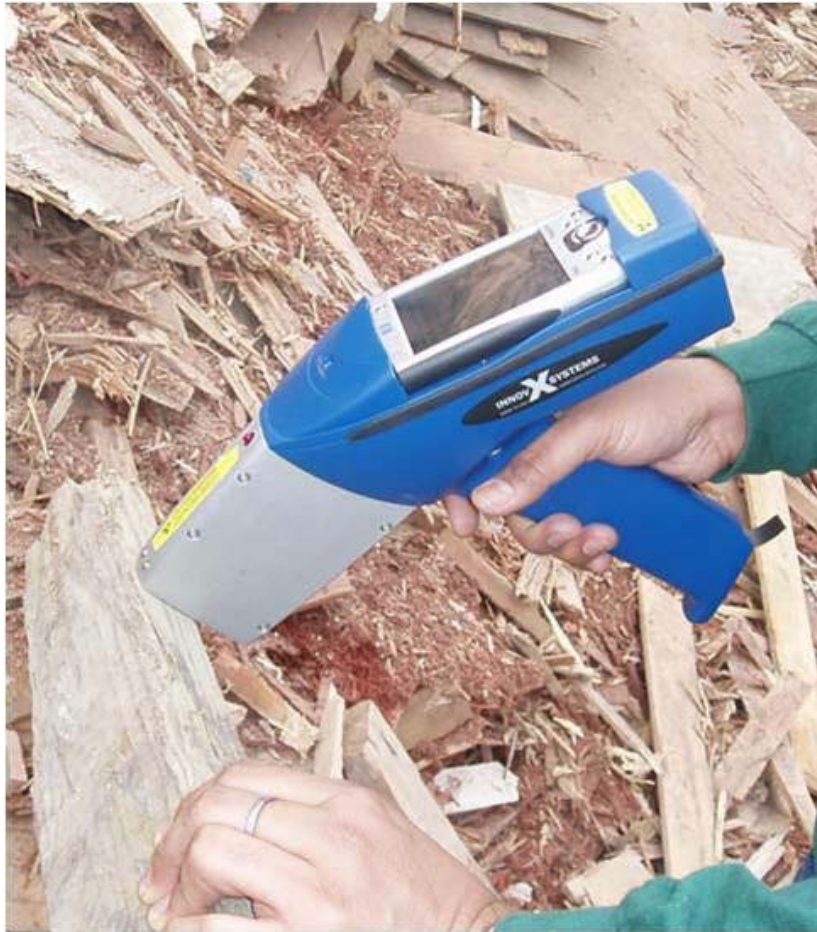
XRF Gun Photo: Helena Solo-Gabriele

Another method used to identify treated wood is x-ray fluorescence, or XRF, because each individual element such as copper, chromium, and arsenic has its own measurable fluorescence identifier. By pointing a portable hand held device, shaped like a gun, at the wood, concentrations of set elements can be calculated in a matter of seconds. XRF technology is versatile and has been used on rocks, soil, and even more recently on children's toys.

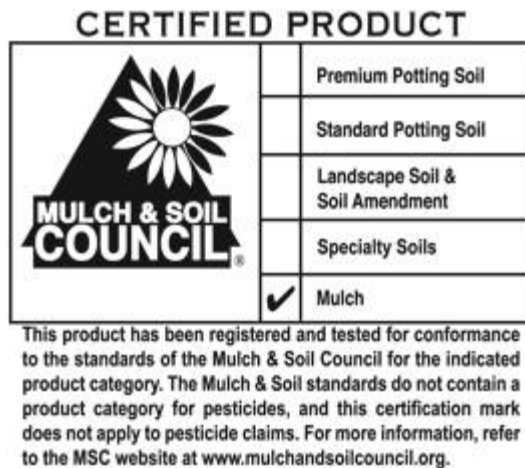
Mulch label Credit: MSC

Products that pass the test are labeled with the MSC certification seal and listed on the council’s website. The council admits that it is not possible to test every bag of mulch, but believes that random testing and exposure of those who violate the certification process has been a deterrent to using CCA treated wood.
