## CCA Treated Wood

The End of the Line

MSW Management

August 2, 2010

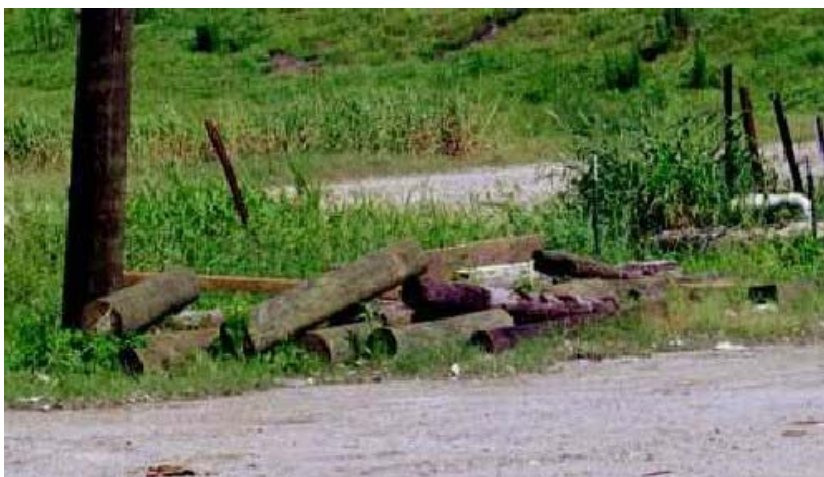
Telephone Poles Photo: Florida DEP

Larger pieces of CCA treated wood used for industrial purposes, such as railroad ties and utility poles, are easily identifiable. But smaller pieces from residential use are harder to find and pull out. Not quite a needle in a haystack, but close. Even with smaller pieces, it's often the shape of the material that's used to determine whether it should be pulled from the pile. If wood waste looks like it came from outdoor decking or fencing, it should be pulled to the side.

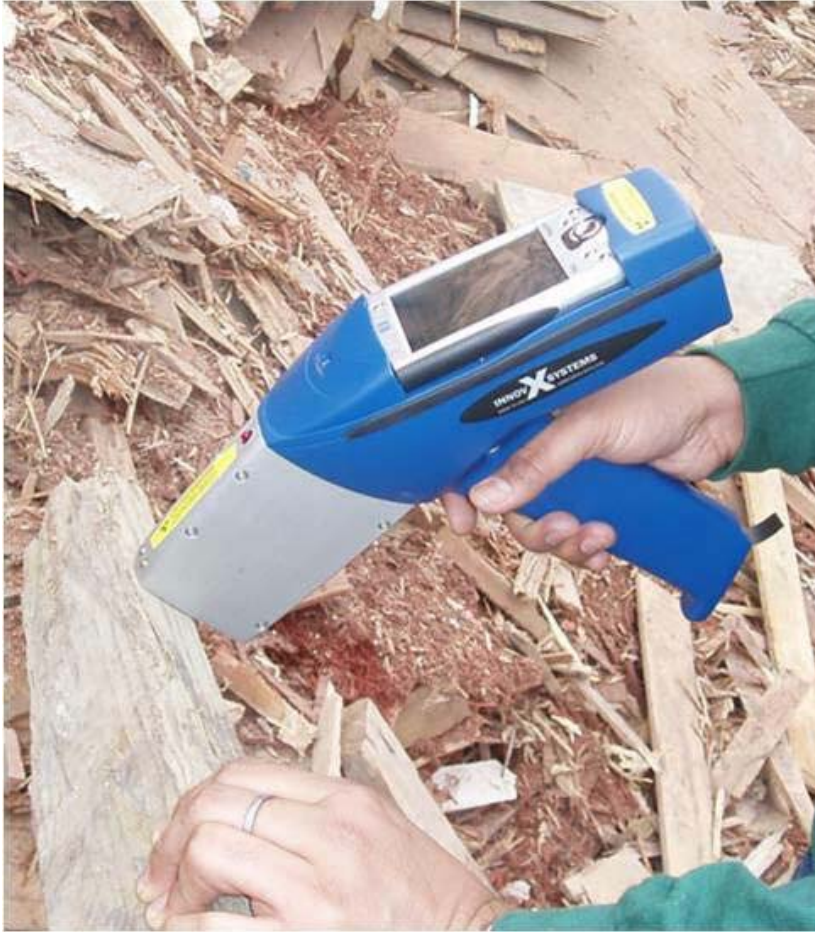
XRF Gun Photo: Helena Solo-Gabriele

Another method used to identify treated wood is x-ray fluorescence, or XRF, because each individual element such as copper, chromium, and arsenic has its own measurable fluorescence identifier. By pointing a portable hand held device, shaped like a gun, at the wood, concentrations of set elements can be calculated in a matter of seconds. XRF technology is versatile and has been used on rocks, soil, and even more recently on children's toys.

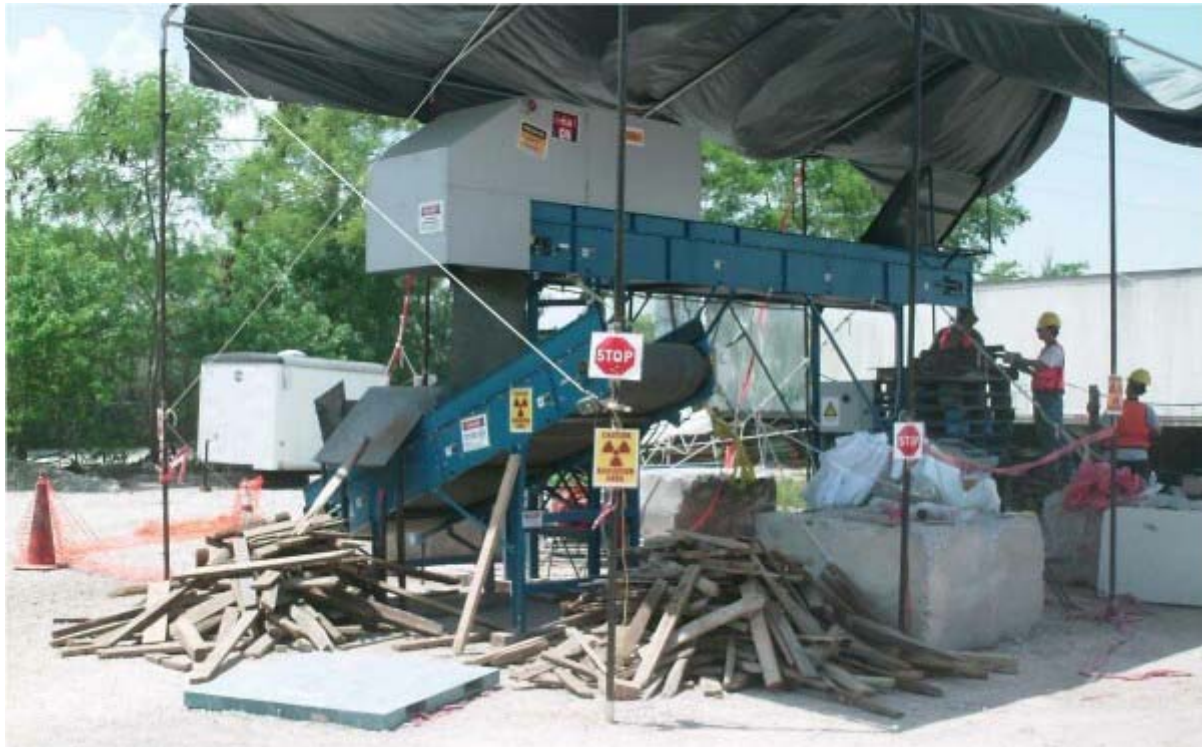
XRF Helena Photo: Solo-Gabriele

But visual inspection is still time consuming. That's why Solo-Gabriele is working on potential full-scale methods to identify and sort out prohibited wood. Solo-Gabriele's pilot study employs XRF technology to effectively identify and ultimately sort CCA treated wood from an incoming stream. Her efforts utilize an on-line configuration, as opposed to a hand held version of the equipment, as its more amenable to full-scale application.

Solo-Gabriele had considered other technologies for the pilot study, but the identification rates using the XRF were higher than those with visual and PAN indicator. Not only was better separation achieved, the XRF could be used on wet and dirty wood and is able to identify numerous elements in a matter of seconds.
